Reparação de Emergência do Quebra-Mar – Fase 1

Puerto Militar – Praia da Vitória, Açores

Breakwater Emergency Repair – Stage 1

POL Pier – Praia da Vitória, Azores

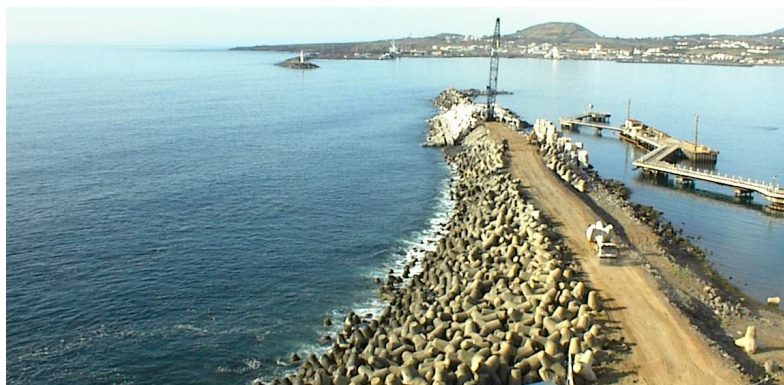
Topo: aspecto da zona dos trabalhos

Top: site, general view

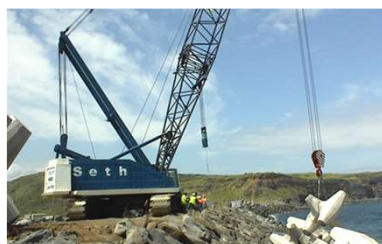
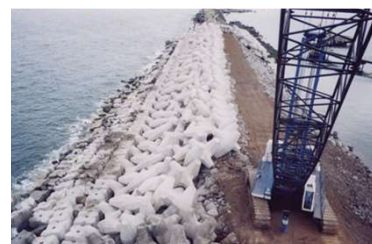
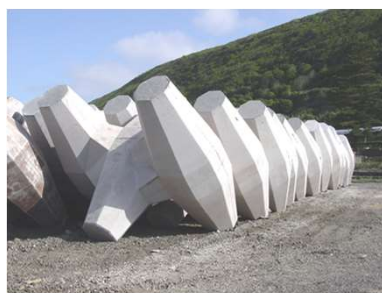
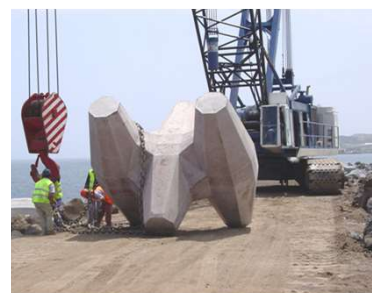
Imagens inferiores: CORE-LOC e antifers
Lower images: CORE-LOC unit and antifers
